Manhole Inspection Summary

Manhole # S67Q__008MH

Insp Date: **5/15/08 9:07 AM**

Location Address: **1525 Charlotte Ave.**

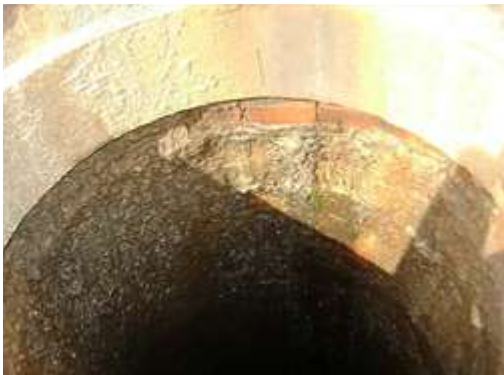
Defect 2

Infiltration: ☐ None ☐ Joint ☐ Cracks ☒ **Mortar** ☐ Roots ☐ Wall

Infiltration in barrel

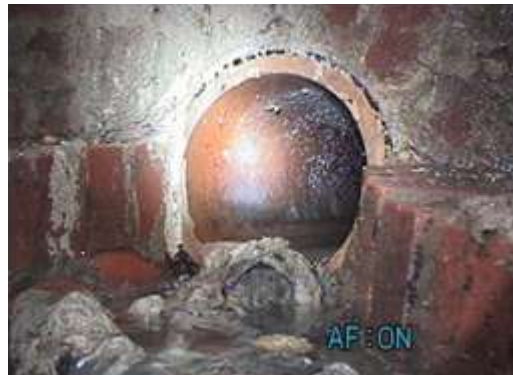
Defect 3

broken pipe seal 10:00-3:00 incoming 9 o'clock

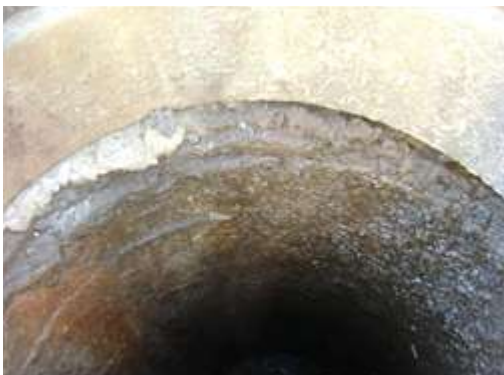
Defect 1

Frame Offset: **1** (in.) Condition: ☒ Sound ☐ Cracked ☐ Leaks

Offset frame defect.

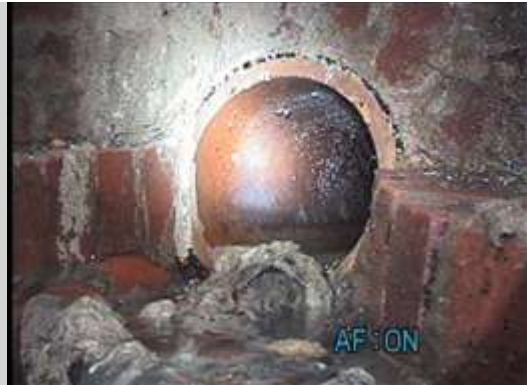
9 O'Clock Inflow

Infiltration: **None** Pipe Seal Cond: **Broken**
